Operating Experience Weekly Summary 97-40

September 26 through October 2, 1997

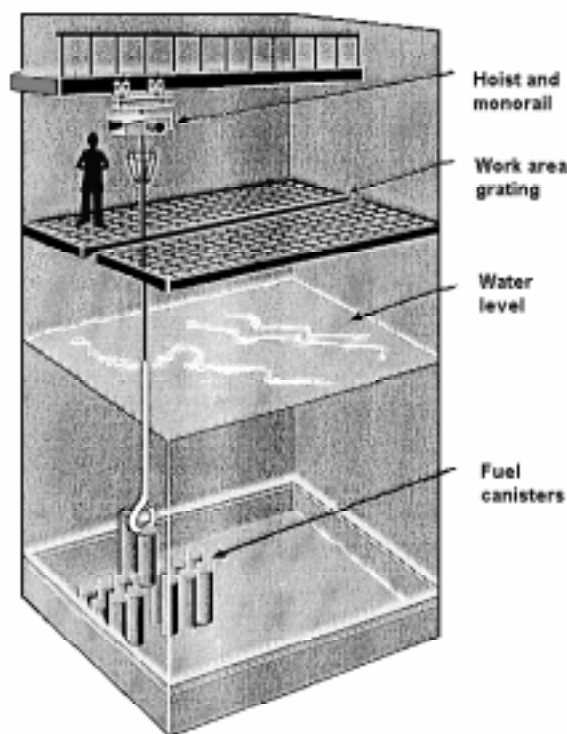
Figure 1-1. Canister-Handling Layout

The facility manager held a critique of the event. Critique members determined that an operator was moving the canister from a fuel storage rack so an adjacent, out-of-position, rack could be repositioned. He engaged the fuel canister with the straight-hook on an electric chain-fall that is routinely used to move canisters. Lifting and rigging personnel are making slings to be used to recover the canister. Facility personnel continue to review this event to determine the cause. Further investigation and recovery of the dropped canister are required before fuel movement activities can resume. Figure 1-1 shows a typical canister-handling layout.

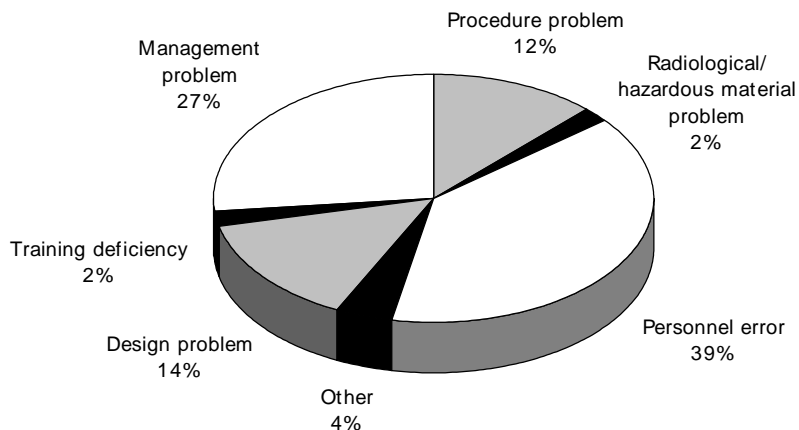
Figure 2-1. Distribution of Root Causes for Inadequate Lockouts¹

OEAF engineers reviewed the ORPS database for inadequate lockouts across the DOE complex and found 49 occurrences. Figure 2-1 shows that facility managers reported personnel error as the root cause for 39 percent of the occurrences. They also reported that management problems accounted for 27 percent of the violations. Further review shows that 47 percent of the personnel errors were reported as inattention to detail, and 46 percent of the management problems were reported as work organization/planning deficiency.

These events underscore the need for lockout preparers to ensure that the lockout/tagout addresses all isolation boundaries. It is also important for the worker to verify these boundaries and to perform a zero energy check. Personnel performing zero energy checks on electrical equipment should use only approved test equipment that has been verified operable and should know where in the system to perform these checks. DOE-STD-1030-96, *Guide to Good Practices for Lockouts and Tagouts*, states that every isolation from an energy source must be verified. The initial verification should include a review of pertinent controlled drawings or manuals and a hands-on check of the equipment to help identify obscure sources of power. Although both the Oak Ridge and Savannah River events involved inadequate lockouts, injury was avoided at Savannah River because a zero-energy check identified the shock hazard. Facility managers should review DOE/EH-0540, Safety Notice No. 96-05, "Lockout/Tagout Programs." The notice summarizes lockout/tagout events at DOE facilities, provides lessons learned and recommended practices, and identifies lockout/tagout program requirements. Safety Notice 96-05 can be obtained by contacting the ES&H Information Center, (301) 903-0449, or by writing to ES&H Information Center, U.S. Department of Energy, EH-72/Suite 100, CXXI/3, Germantown, MD 20874.

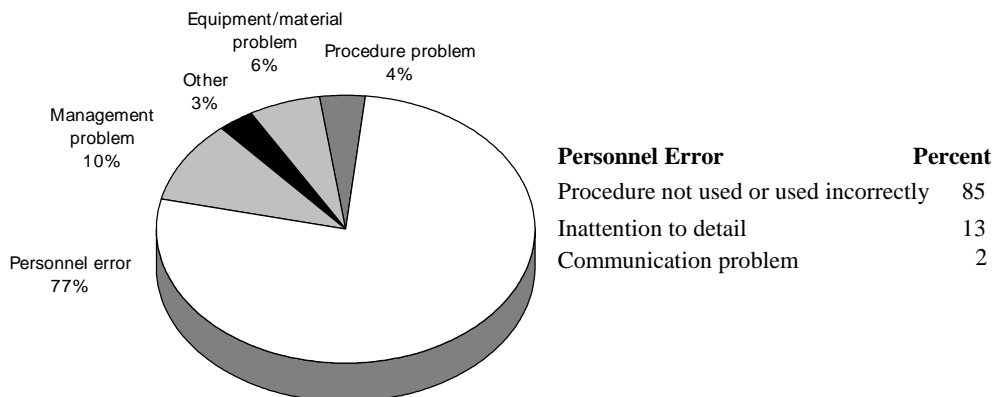
Figure 3-1. Direct Causes for Confined Space Violations¹

OEAF engineers reviewed the ORPS database and found 71 reports associated with confined space violations. Figure 3-1 shows that facility managers reported personnel error as the direct cause for 77 percent of these events. Further review determined that procedure not used or used incorrectly accounted for 85 percent of the personnel errors.

Facility managers and personnel responsible for implementing confined space entry programs should ensure that all aspects of OSHA standards are incorporated into procedures and effectively implemented by workers who enter confined spaces. OSHA also requires training to ensure that employees involved in confined space work can perform their job functions safely. This training covers specific items for the authorized entrant, the attendant, and the entry supervisor. Training for confined spaces should be rigorous and should ensure that workers understand the requirements as well as the potential consequences of their actions.
